MFC Communications Infrastructure Study

January 2012

INL/EXT-11-23733

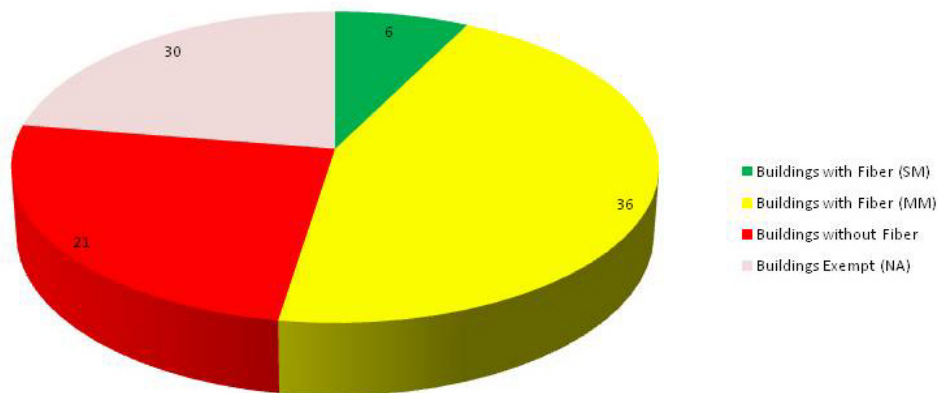
MFC Building Fiber Summary

FIGURE 2. STD-170 Fiber Optic Cabling. Subsidiary buildings shall be supported by 48 single-mode fiber strands and core buildings shall be supported with 144 single-mode fiber strands.

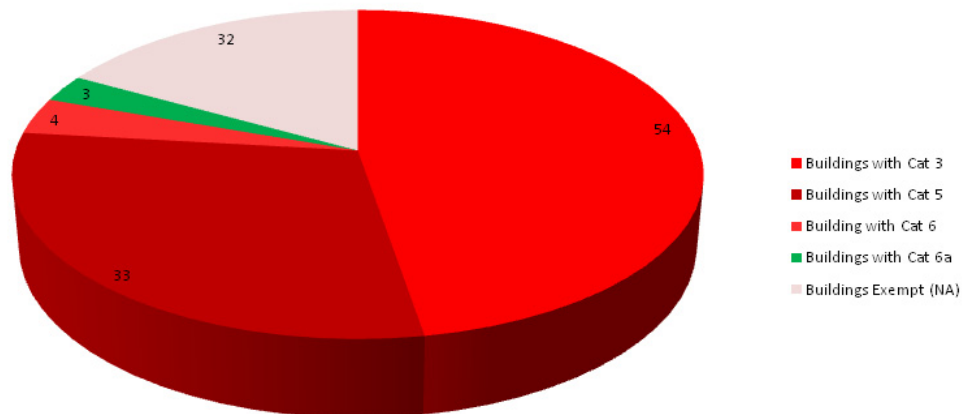
MFC Building Cabling Deficiency Summary

STD-170 identifies CAT 6A as standard (some buildings have a mix of cable types).

FIGURE 3. STD-170 identifies Cat 6A as standard (some buildings have a mix of cable types). (Cat 3 is most deficient, whereas Cat 6a not deficient.)

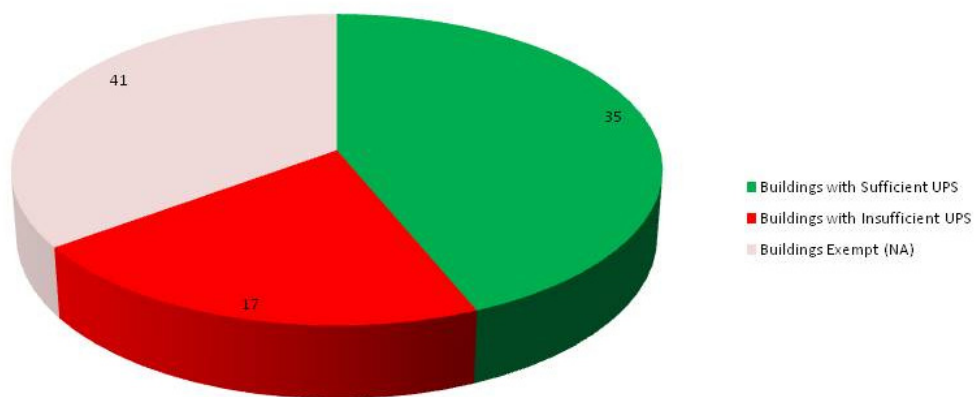
MFC Building UPS Summary

FIGURE 4. STD-170 identifies pathway and space standards.

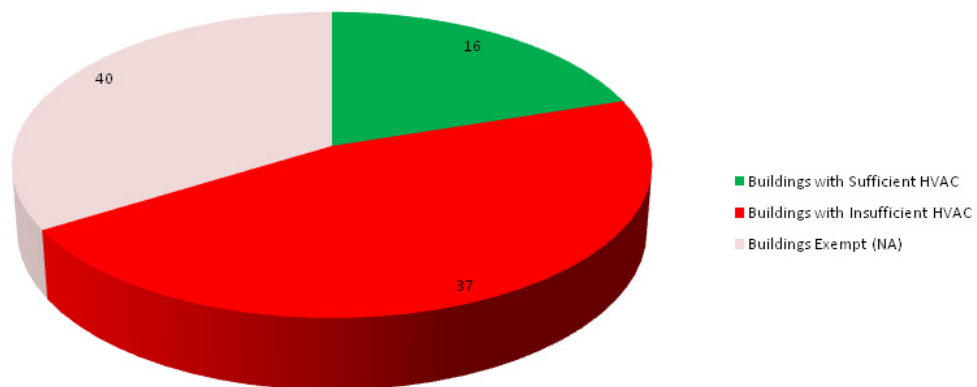
MFC Building HVAC Summary

STD-170 identifies Environmental Control (HVAC)

FIGURE 5. MFC Building HVAC Summary.

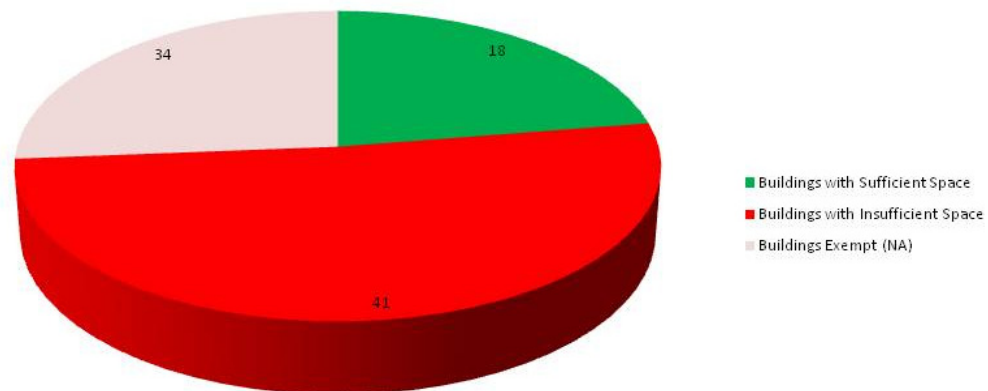
MFC Building Space Summary

FIGURE 6. STD-170 identifies pathway and space standards.

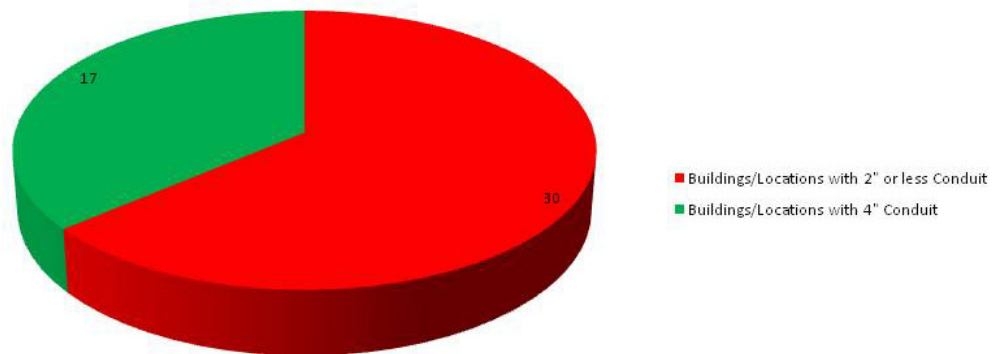
MFC Campus Conduit Summary

The MFC campus has a mixture of conduit pathway configurations. STD-170 specifies that conduit shall be a minimum of 4 inches to allow for growth and usability. The following chart is a summary of the conduit duct bank identified on the MFC campus drawing. Approximately 30 duct-bank routes are used to connect building entry conduits.

FIGURE 7. STD-170 identifies pathway standards.

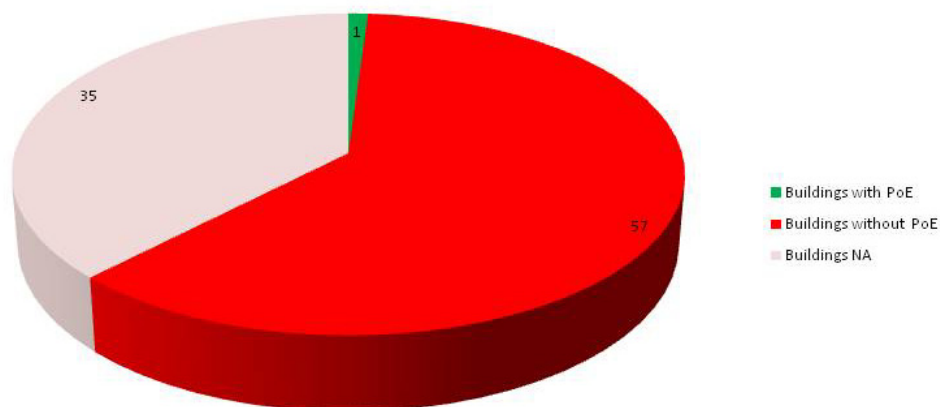
Building with Power over Ethernet (PoE)

FIGURE 8. Power over Ethernet is required for VoIP.

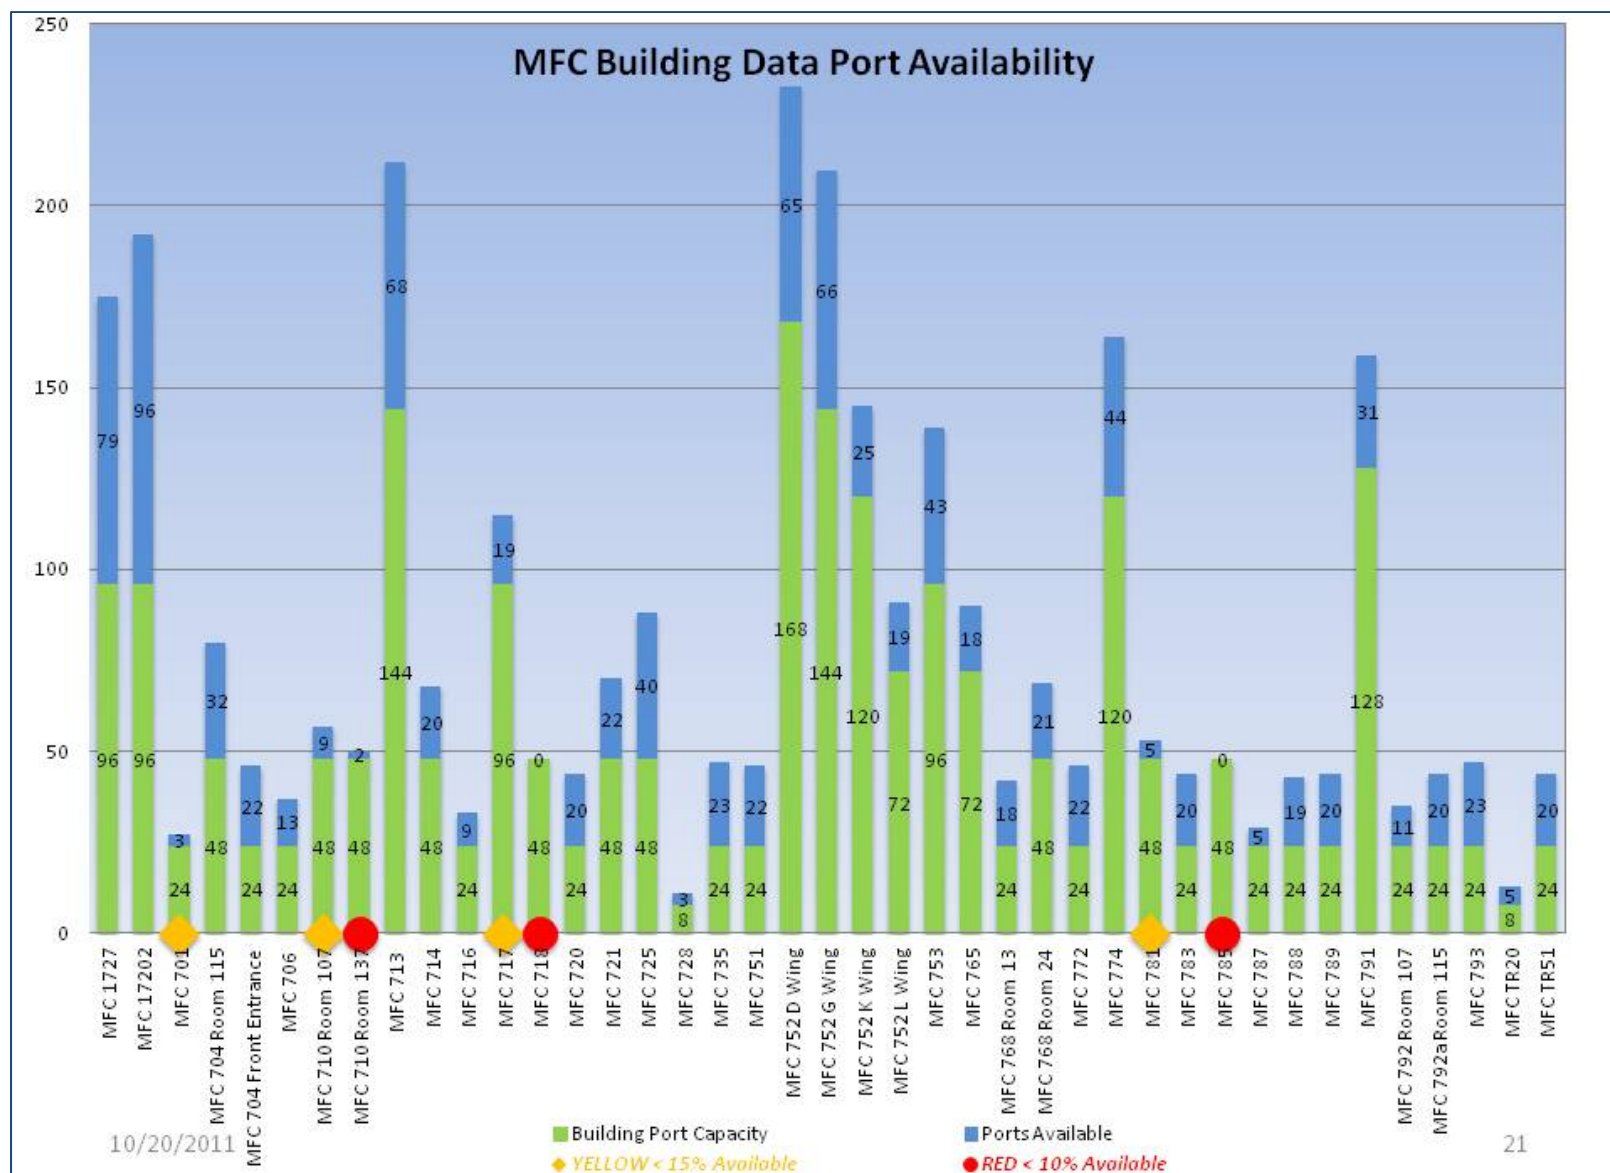
2.3 MFC Building Data Port Availability Bar Graph

The following chart displays the total number of data ports and how many ports are currently available. Only those facilities that have data connectivity are represented. A facility may be served by two or more telecommunications rooms. In these cases, the number of ports for each telecommunications room is represented. The bar graph is a snapshot in time and represents data as of September 2011. The data is dynamic and changes frequently as new services are deployed to customers.

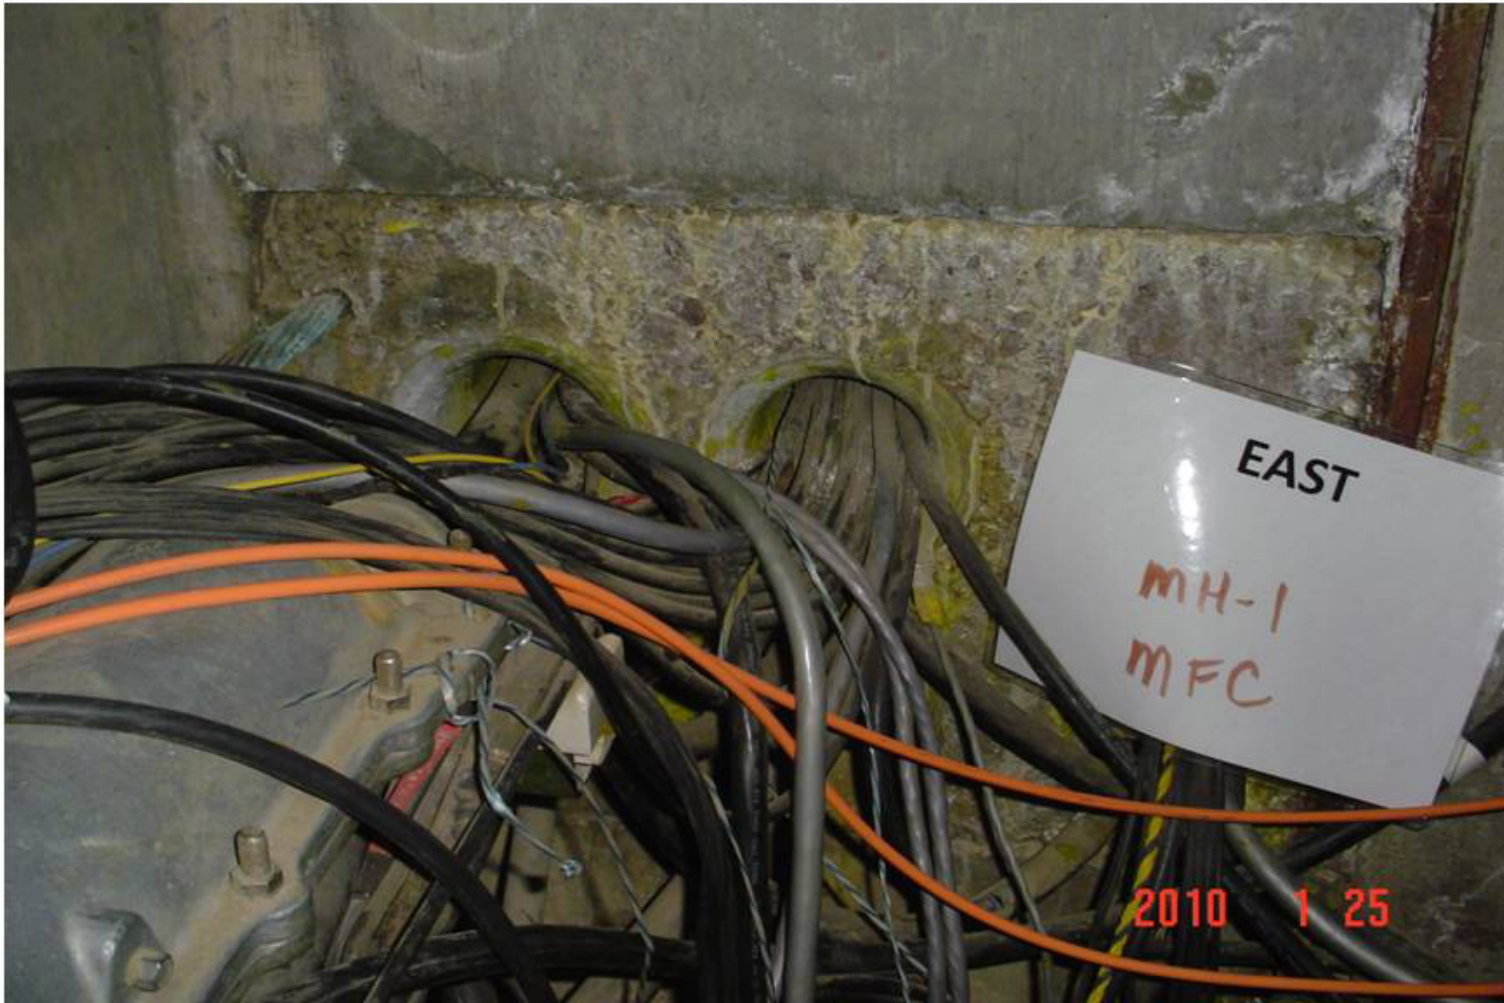
EXAMPLE DEPICTS A MANHOLE AT CAPACITY WITHOUT INNERDUCT

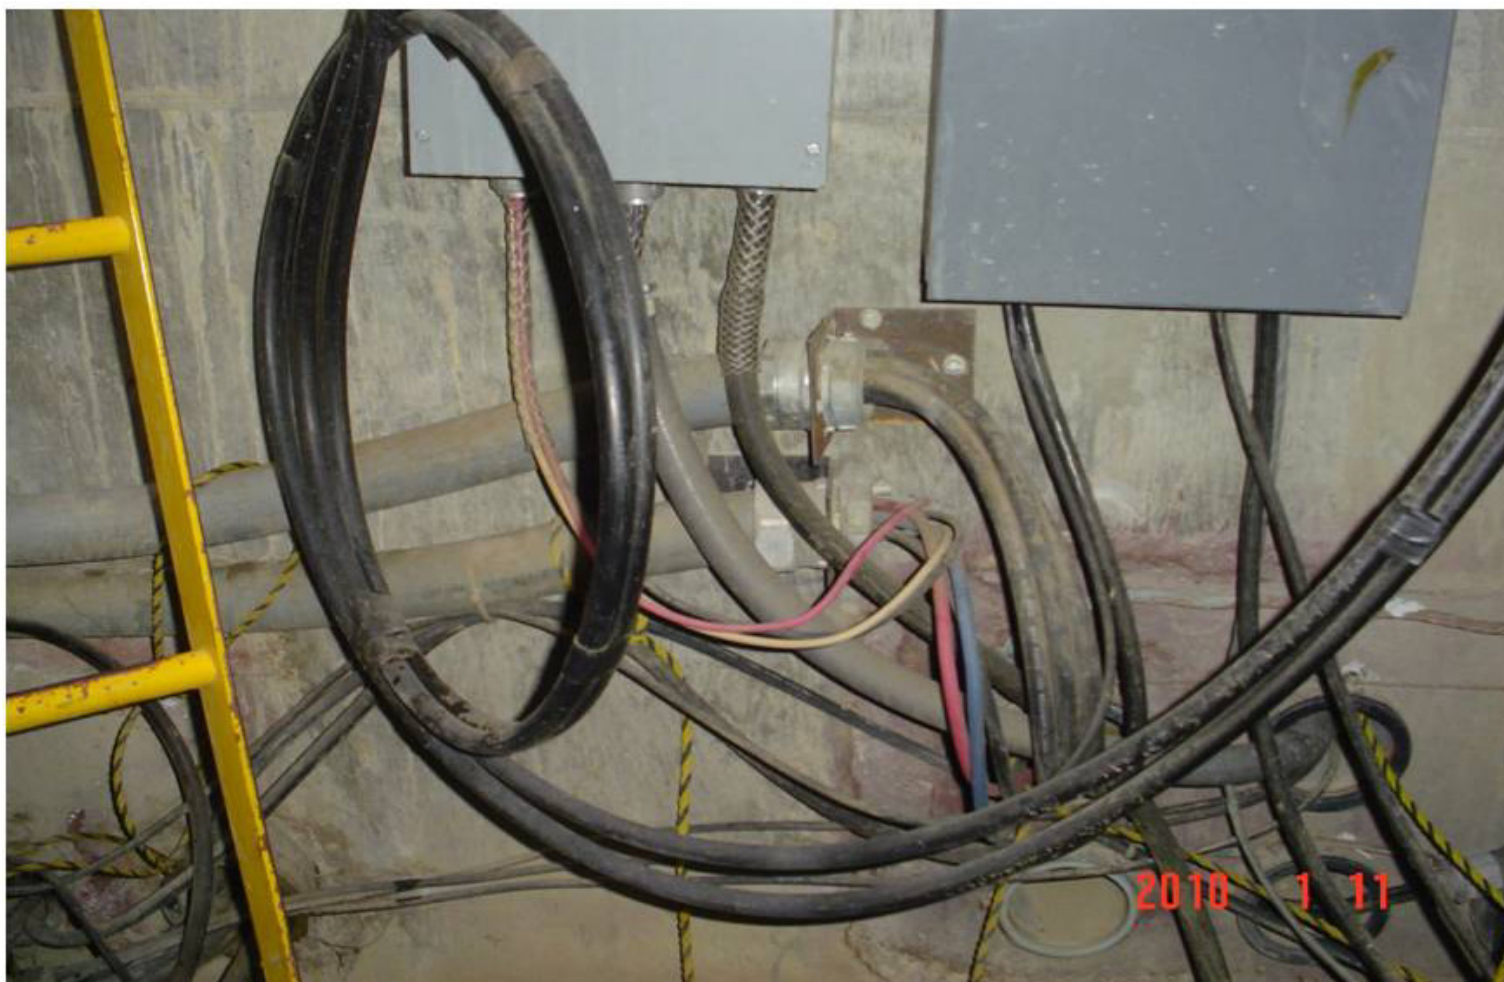
EXAMPLE DEPICTS A SAFETY CONCERN WITH CO-LOCATED HIGH AND LOW VOLTAGE CABLES

- IMCL/CESB project provides an alternate route for the northeast side of MFC-752 avoiding the co-resident high and low voltage safety concerns present in the existing duct bank route. This does not address the rerouting of cables from the old duct-bank to the new. Working in the old duct bank route manholes will remain a safety concern and activities in these manholes will require a power impairment.

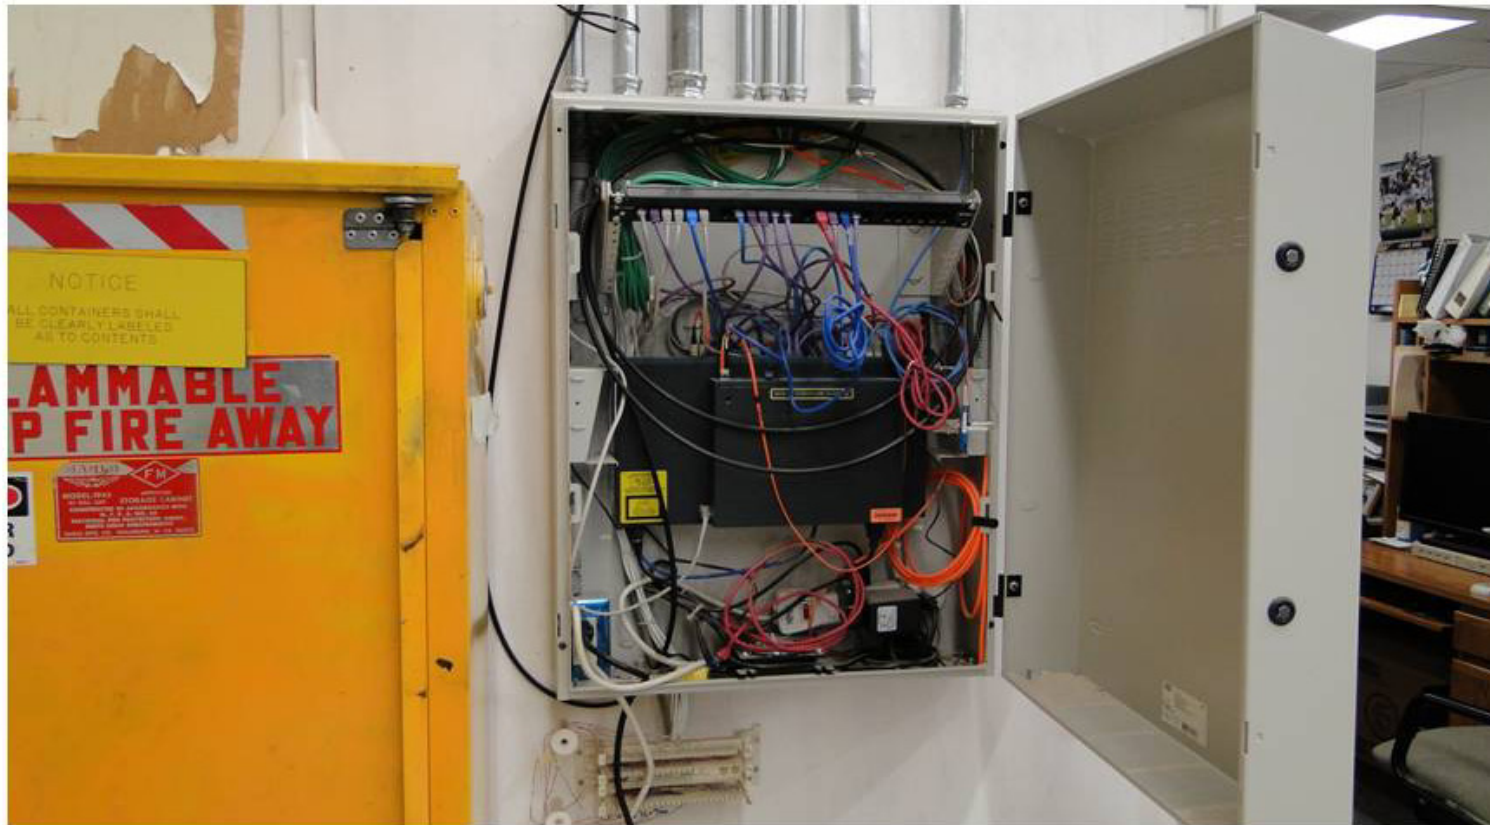
EXAMPLE DEPICTS NONCOMPLIANT UPS AND CABLING AT MFC-788

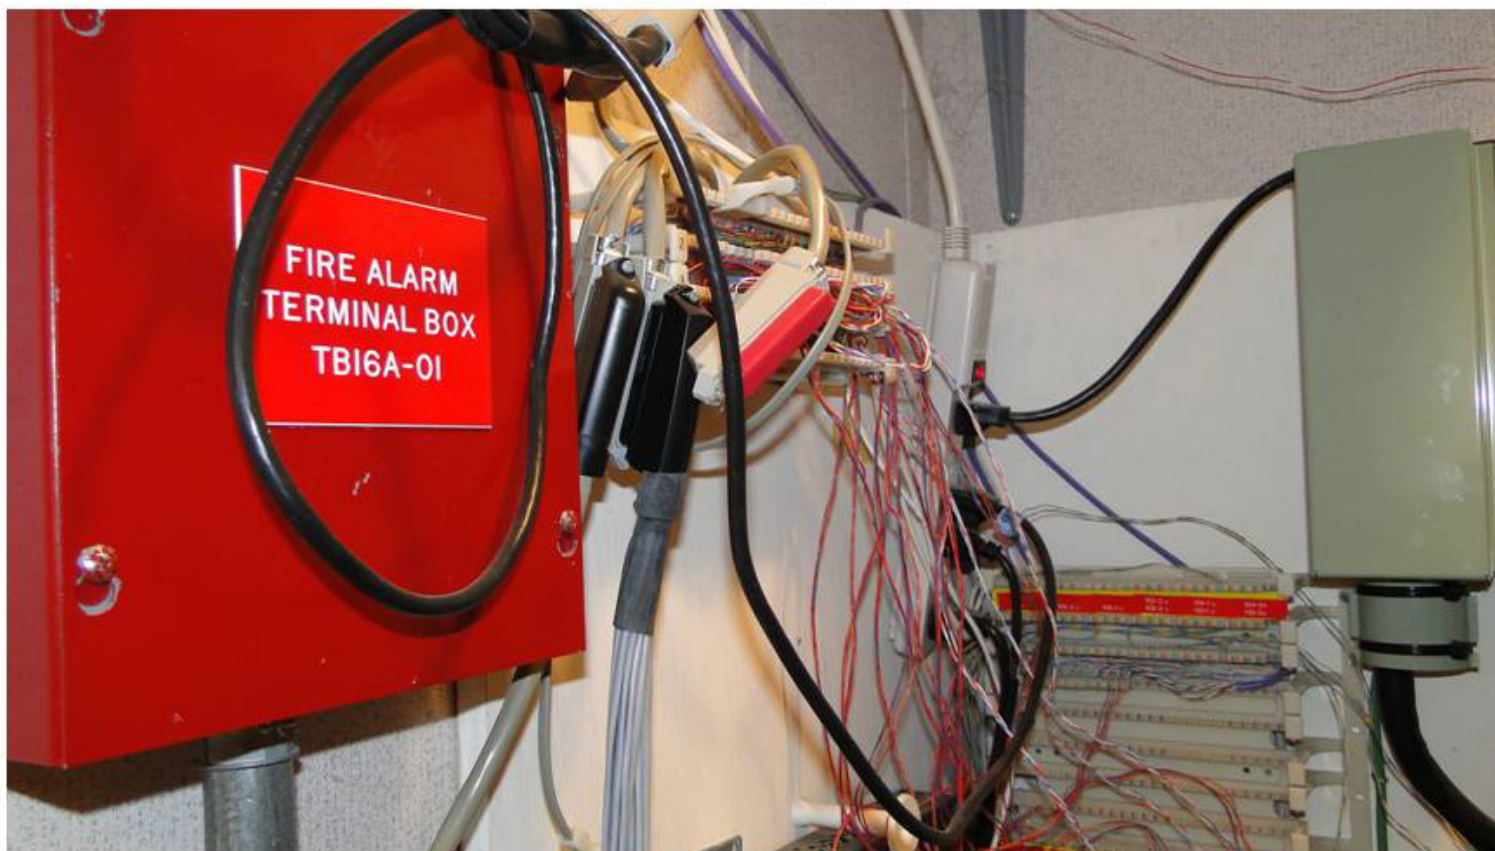
EXAMPLE DEPICTS INSUFFICIENT SPACE AND LACK OF CABLE MANAGEMENT AT MFC-716

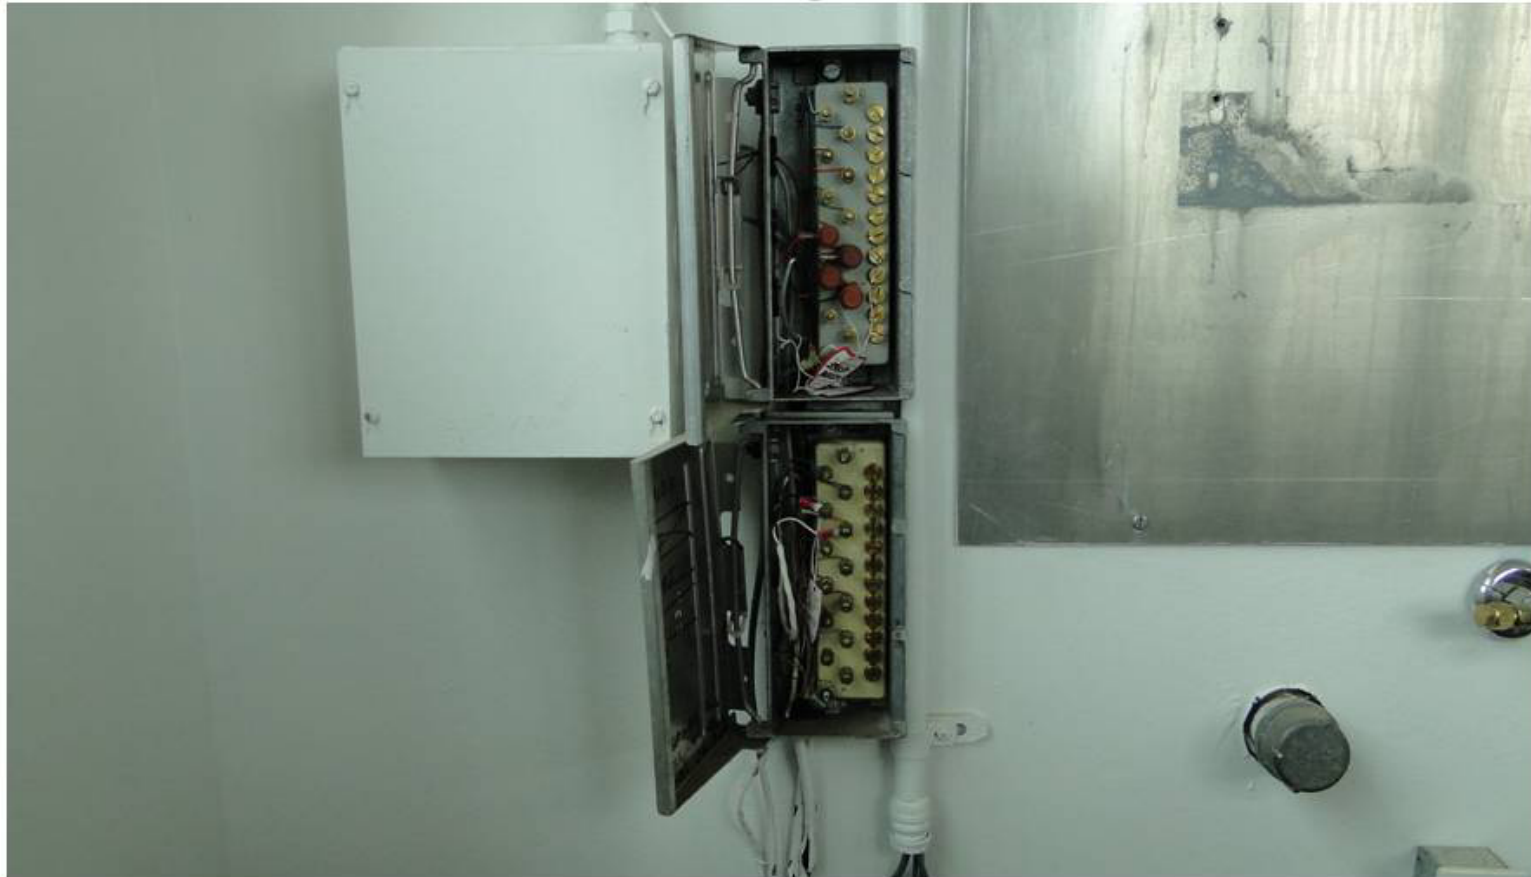
EXAMPLE DEPICTS OUTDATED TECHNOLOGY AND INSUFFICIENT SPACE AT MFC-722
